PARKER POND
NDI NO. MD 00085

PHASE I INSPECTION REPORT
NATIONAL DAM INSPECTION PROGRAM

Prepared By: Maryland Water Resources Administration
AUGUST 1978

Name of Dam: Parker Pond Dam
State Located: Maryland
County Located: Wicomico
Stream: Beaver Dam Creek
Date of Inspection: 14 July 1978
Inspection By: State of Maryland
Department of Natural Resources
Water Resources Administration

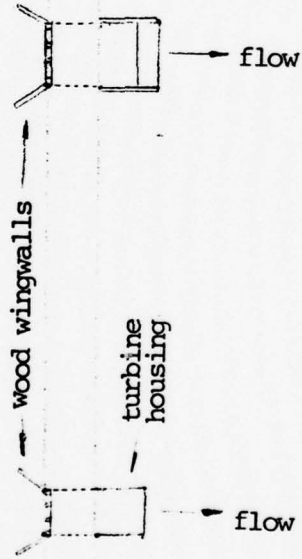
Top view Parker Pond 00085
scale 1"=50'

unplanned overflow
area along paved
road

stream channels converge
1/8 mile downstream
